# FABRICATION AND TESTING OF LIGHTWEIGHT HYDRAULIC SYSTEM SIMULATOR HARDWARE—PHASE II

**Rockwell  
International**

Addendum Report for Period, 2 January 1986–15 July 1988

**NAVAL AIR DEVELOPMENT CENTER**  
**Aircraft and Crew Systems Technology Directorate**  
**Warminster, PA 18974**

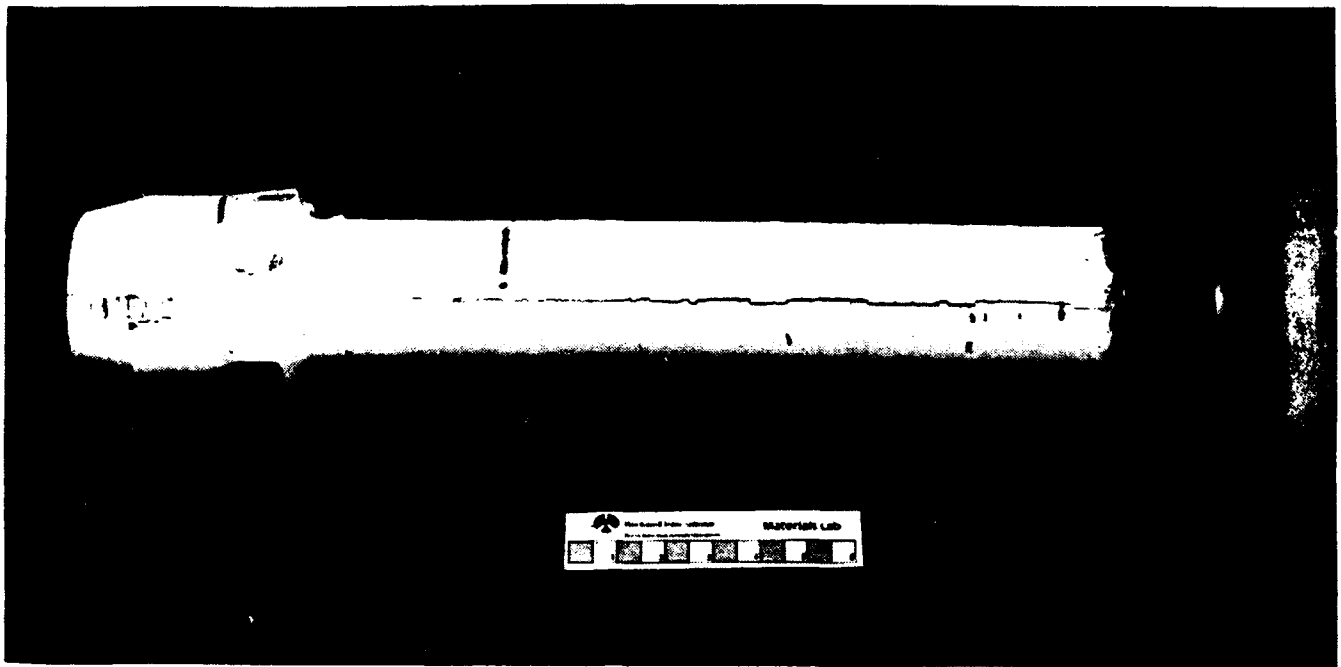
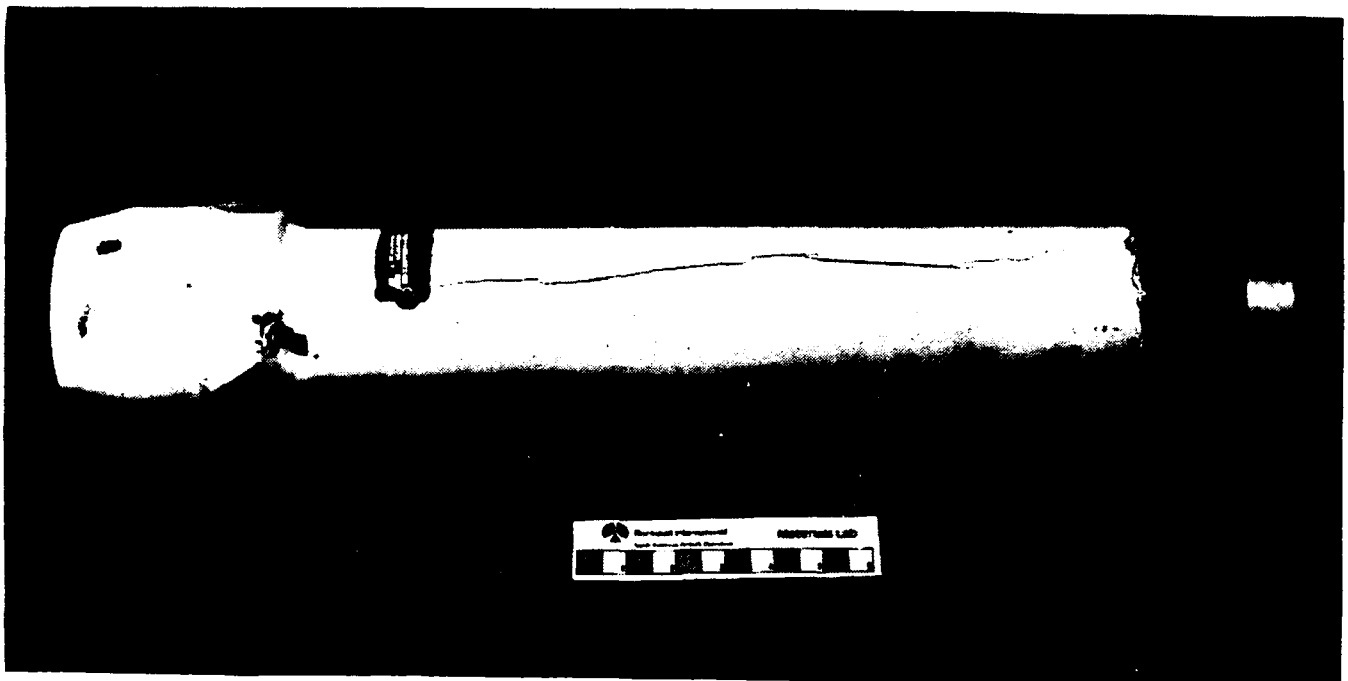
Figure 2. Crack in barrel of speed brake actuator

Speed Brake Actuator. The speed brake actuator experienced a catastrophic failure when the cylinder barrel split after completion of 13,237 full load cycles, Figure 2. The piston rod was near the full extend position and under 40,000 pounds of compressive load at the time of failure. The actuator barrel was made of 7075-T651 aluminum alloy; the inner bore surface was hard anodized for wear protection.

The barrel was separated to permit a metallurgical examination of the fracture surfaces. A large number of crack initiation sites were observed throughout the entire inside surface of the barrel. Numerous fatigue patterns were seen on the fracture surfaces, Figure 3. The area that produced the final rupture is the large semi-circular fatigue pattern.

Scanning electron microscope analysis confirmed the primary cause of failure was fatigue, although examination of the crack initiation sites showed evidence of cleavage patterns that are indicative of brittle, plastic fracture. The cracks were believed to have been initiated by the anodic wear surface which exhibited brittle behavior under high stress, cyclic loading.

Anodic coatings can cause a significant reduction in the fatigue strength of wrought aluminum alloys. The extent to which fatigue strength is reduced depends upon the coating thickness and the composition and temper of the base alloy.

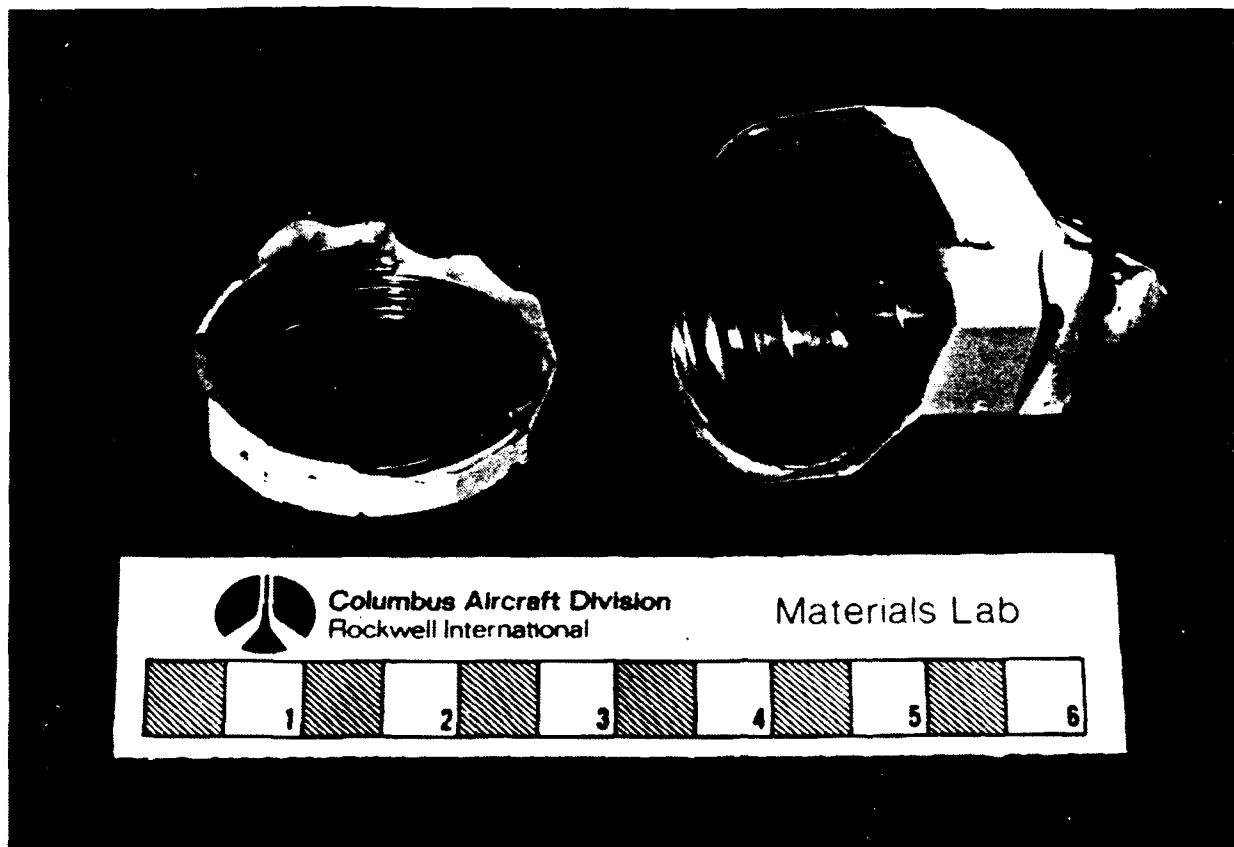
Figure 5. End cap failure in L.E. flap actuator

Actuator assembly instructions require that a 23,000 lb compressive preload be applied to the actuator prior to tightening the end cap lock nut, P/N 83-00262-119. (See drawing in reference 1, Appendix D.) The lock nut is then secured with lockwire. Examination of L.E. flap actuators No. 1, No. 3, and No. 4 revealed this lock nut was loose on all three actuators. The lockwire was intact, but had stretched sufficiently during cycling to permit the lock nut to turn. This condition was believed to have produced the actuator No. 2 failure when loss of the 23,000 lb preload allowed relative motion between the cylinder barrel and end cap. Impact loads thus occurred as the actuator cycled causing stress levels to exceed design values. Lockwire should not be employed to prevent relaxation of torque preloads. A more positive means such as using steel pins to prevent relative motion between the end cap and lock nut should be considered.

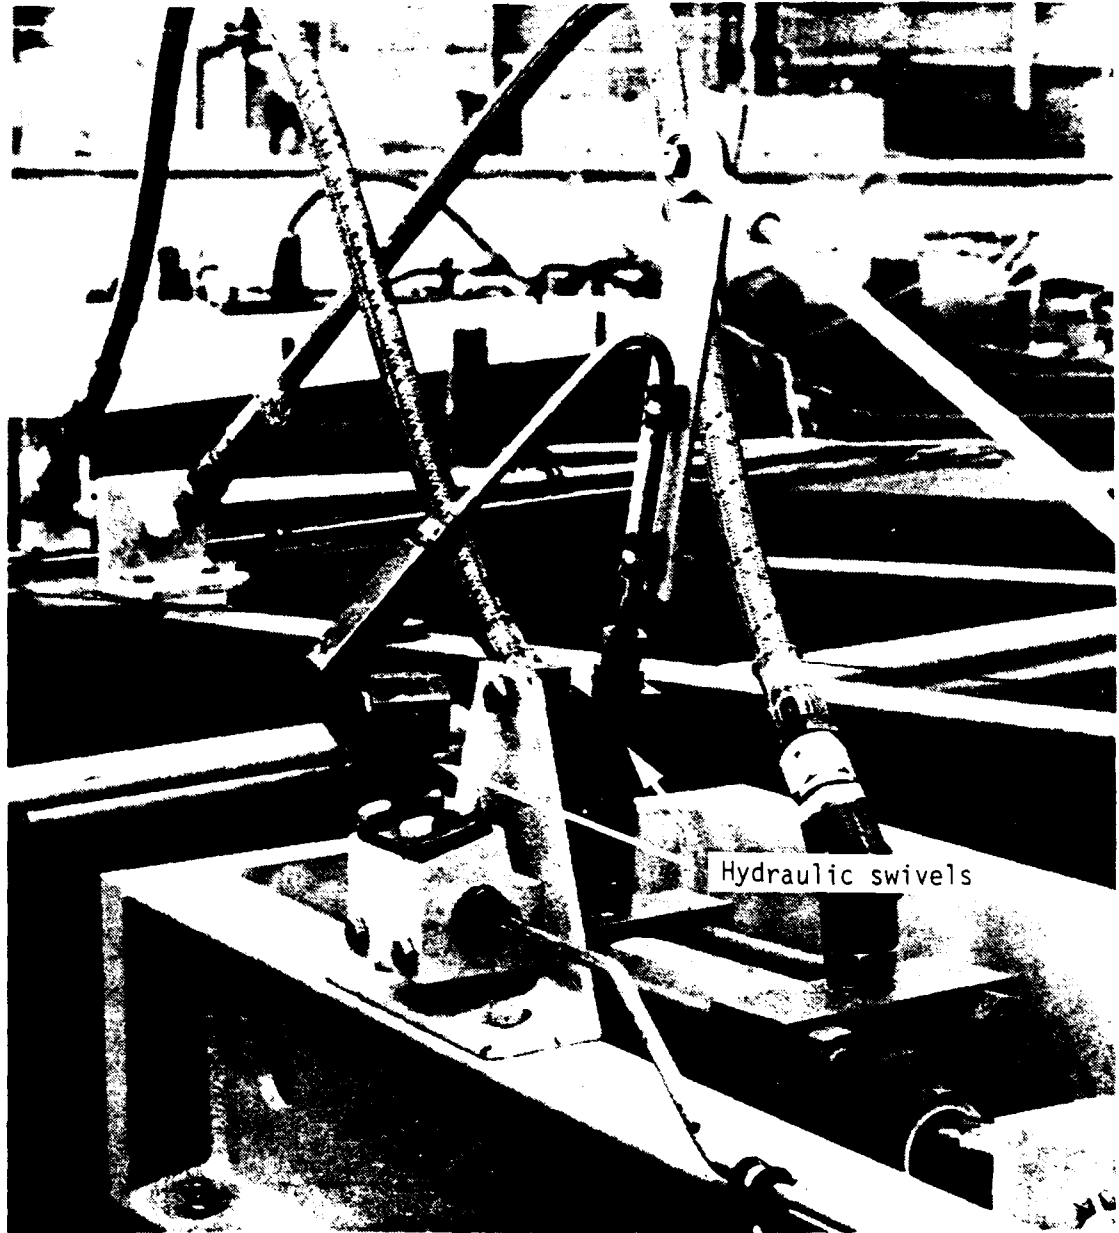
Figure 6. Hydraulic swivel joint cycling setup

Two hydraulic swivel joints were mounted on the LHS speed brake actuator. The joints did not swivel as the actuator cycled because of the load module kinematics, reference 1. The speed brake actuator failed after completing 13,237 cycles, see Section 3.4.2. A setup was subsequently fabricated to oscillate the swivels and permit a better assessment of their endurance capabilities, Figure 6. LHS simulator roll axis controls were used to cycle the swivels. The cycling schedule was therefore based on primary flight control requirements; the swivels were designed for use on a secondary flight control actuator (20,000 cycle life). The accelerated cycling rate provided a means to quickly evaluate the potential life of the swivels. Swivel cycling began at the 954 hour point. Maximum oscillation amplitude was  $\pm 35^\circ$ . Test results are shown on Table 16. The swivel seals are single stage with a capped O-Ring. Swivel performance was considered satisfactory.

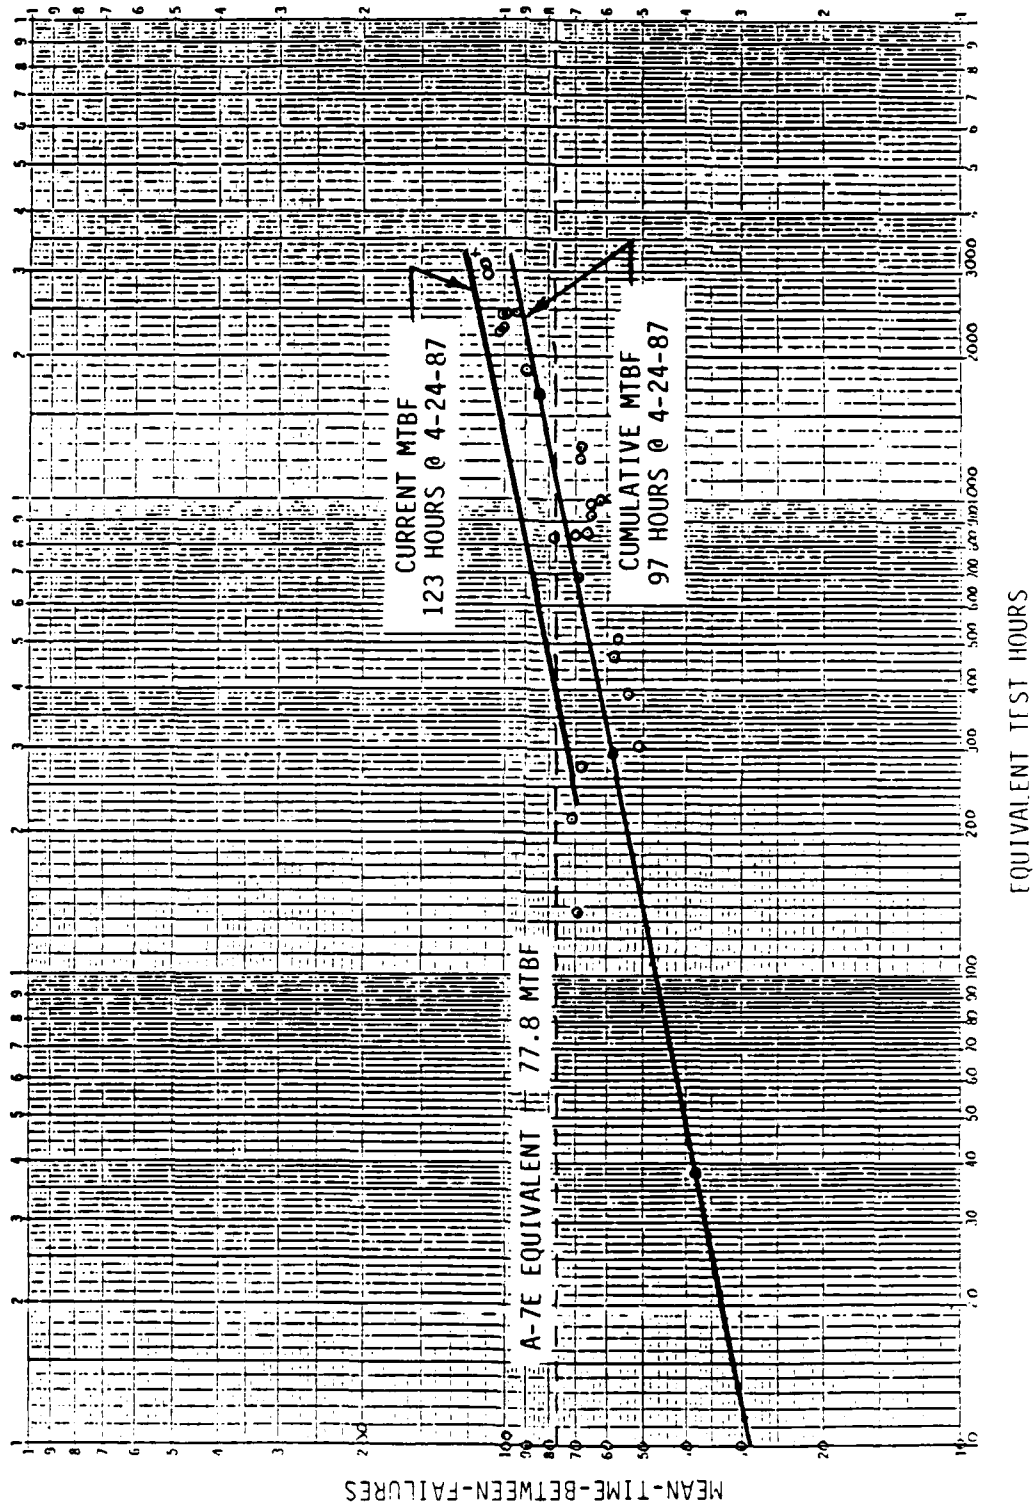
Figure 7. LHS simulator reliability growth, 0 to 1200 hours of operation

NOTE: Summary excludes coil tube failures, pump rework and non-hydraulic related mechanical failures.

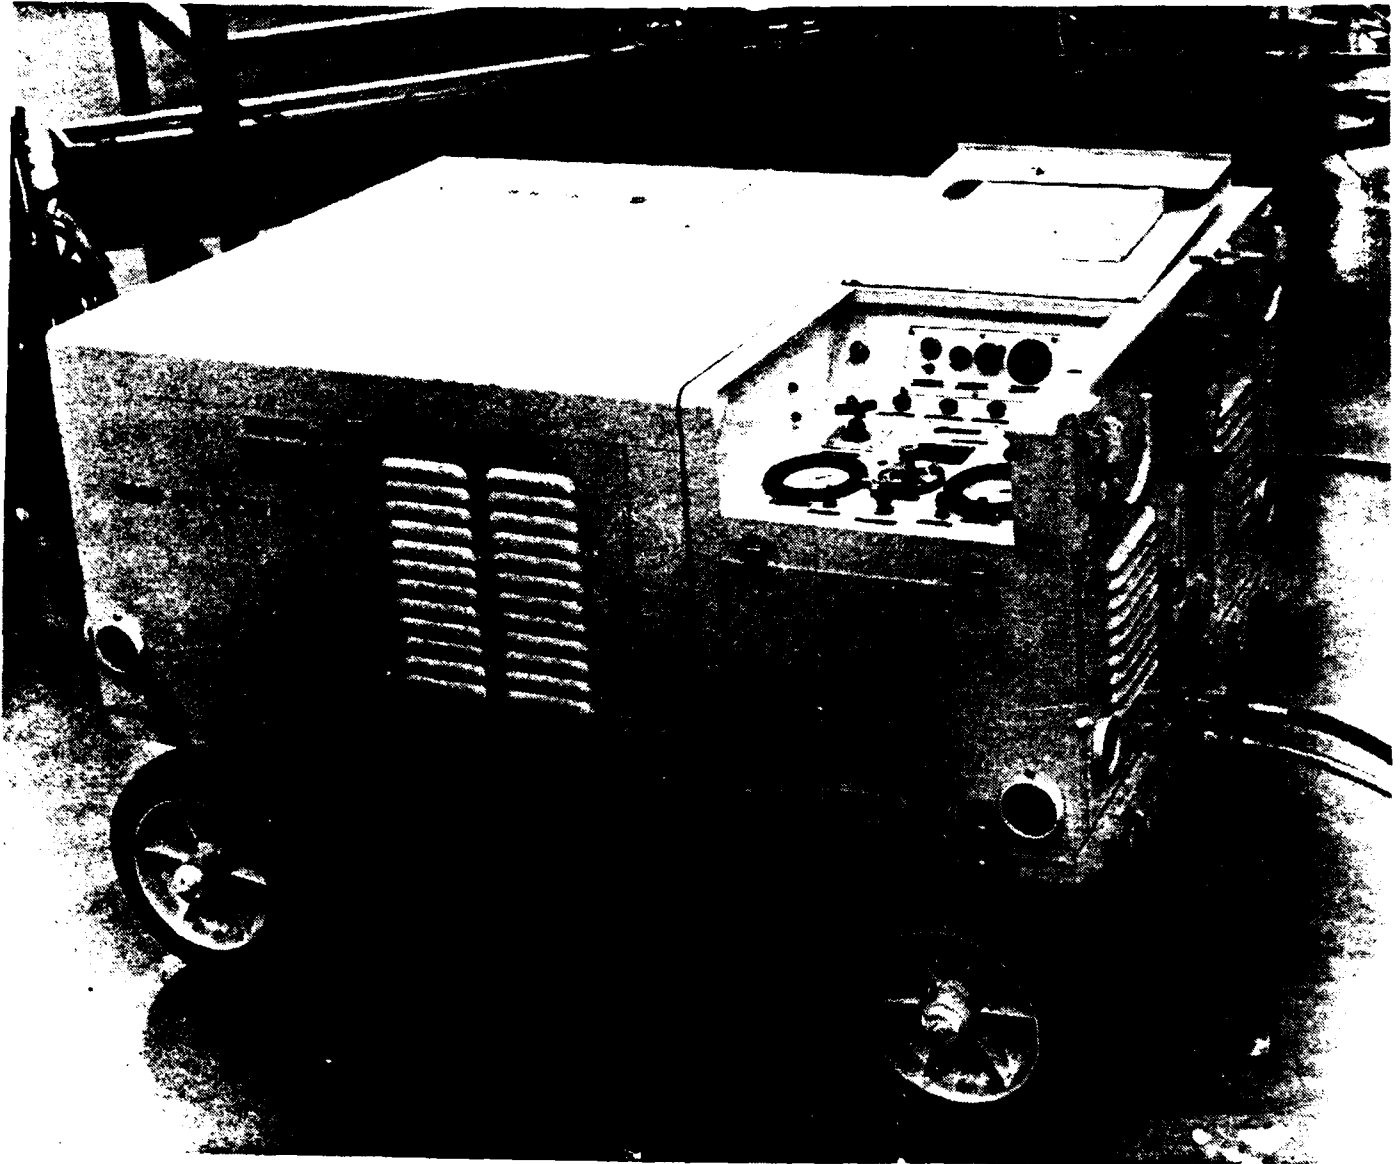
Figure 8. Modified AHT-63 portable test stand

The new GSE pump, Dynex/Rivett M/N PV4018-X6, is a modified version of a 20 year old 5000 psi design originally used on mining machinery and road building equipment. The unit is a check valve type pump with in-line pistons (10), a non-rotating block, and a fixed angle cam. Flow can be manually adjusted up to 10 gpm; pressure compensation is adjustable from 2000 to 9000 psi. The pump installation in the AHT-63 MOD test stand is shown in Figure 9.

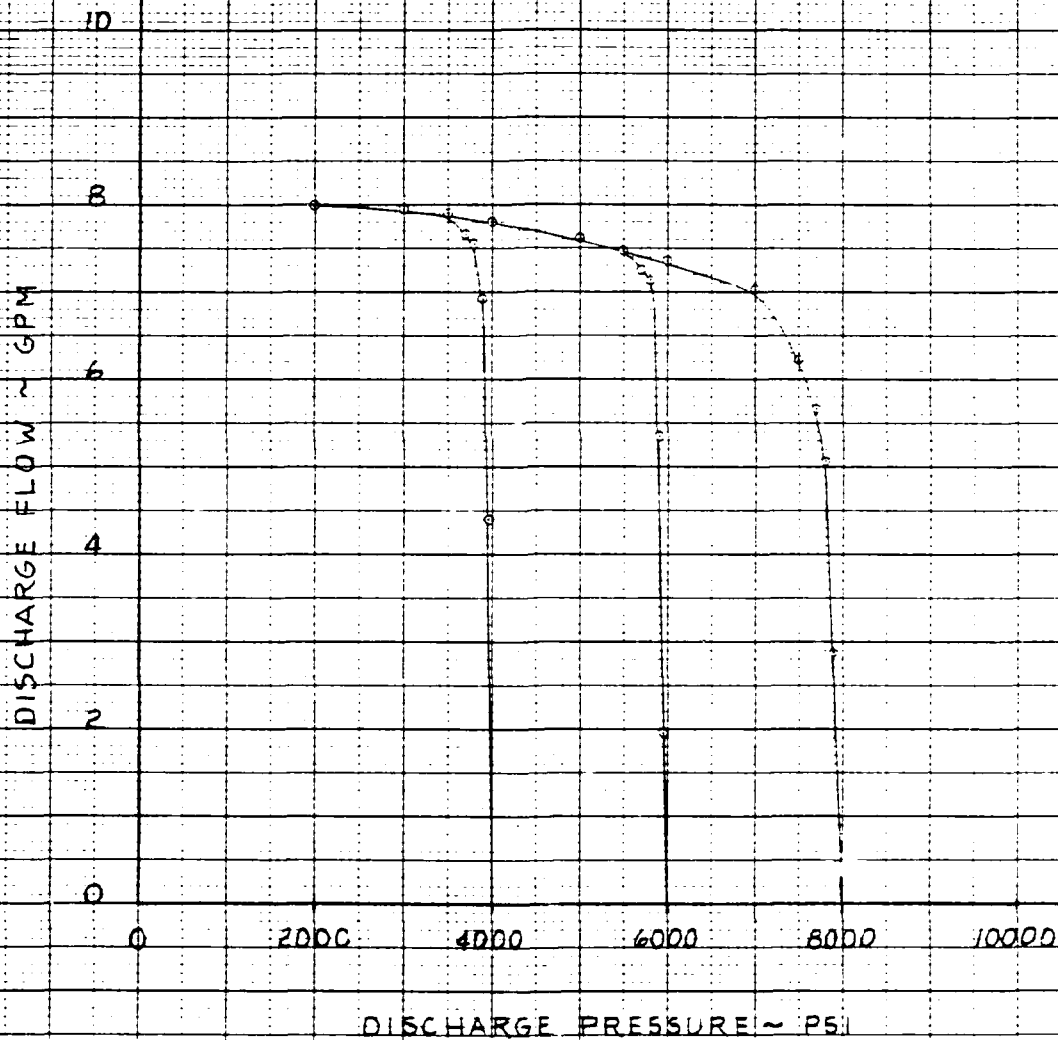
Figure 10. Test stand pressure/flow characteristics

1. AHT-63 PORTABLE TEST STAND MODIFIED FOR 8000 PSI SERVICE.
2. PUMP: DYNEX/RIVETT M/N PV4018-X6
3. SUCTION PRESSURE: 27 PSI
4. CASE DRAIN PRESSURE: 14 PSI
5. SUCTION FLUID TEMP.: +120°F
6. DISCHARGE FLOW MEASURED AT RETURN PRESSURE

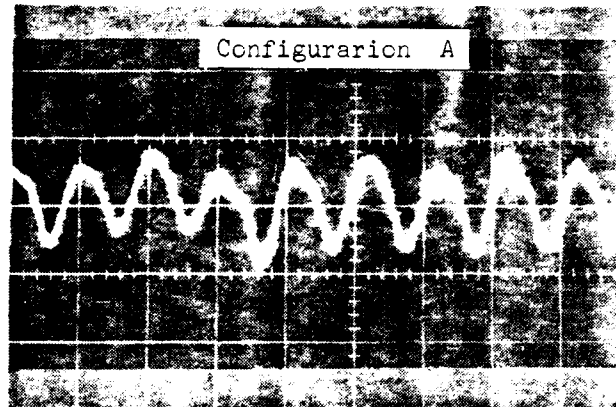
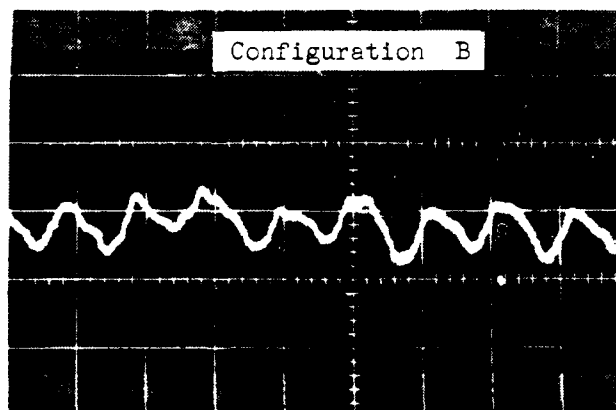
Figure 11. AHT-63 MOD. test stand pressure ripple

A clamp-on type pressure transducer was used to measure pressure ripple, reference 1. Transducer locations and test data are shown on Figures 11 and 12. Ripple was less than 100 psi peak-to-peak with the test stand powering the LHS simulator. This was considered excellent.

Ripple amplitude	100 psi/div
Time	0.005 sec/div

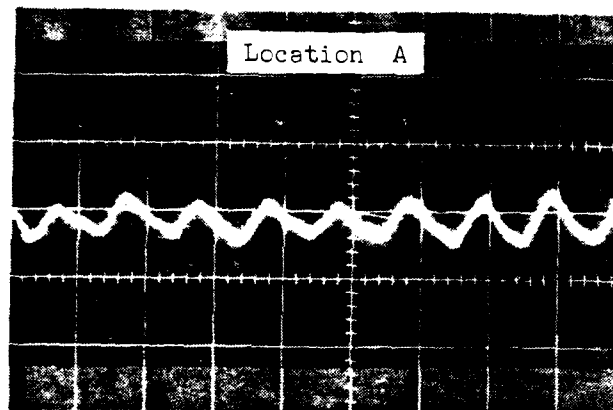
Figure 12. AHT-63 MOD. test stand/LHS simulator pressure ripple

Ripple amplitude	100 psi/div
Time	0.005 sec/div

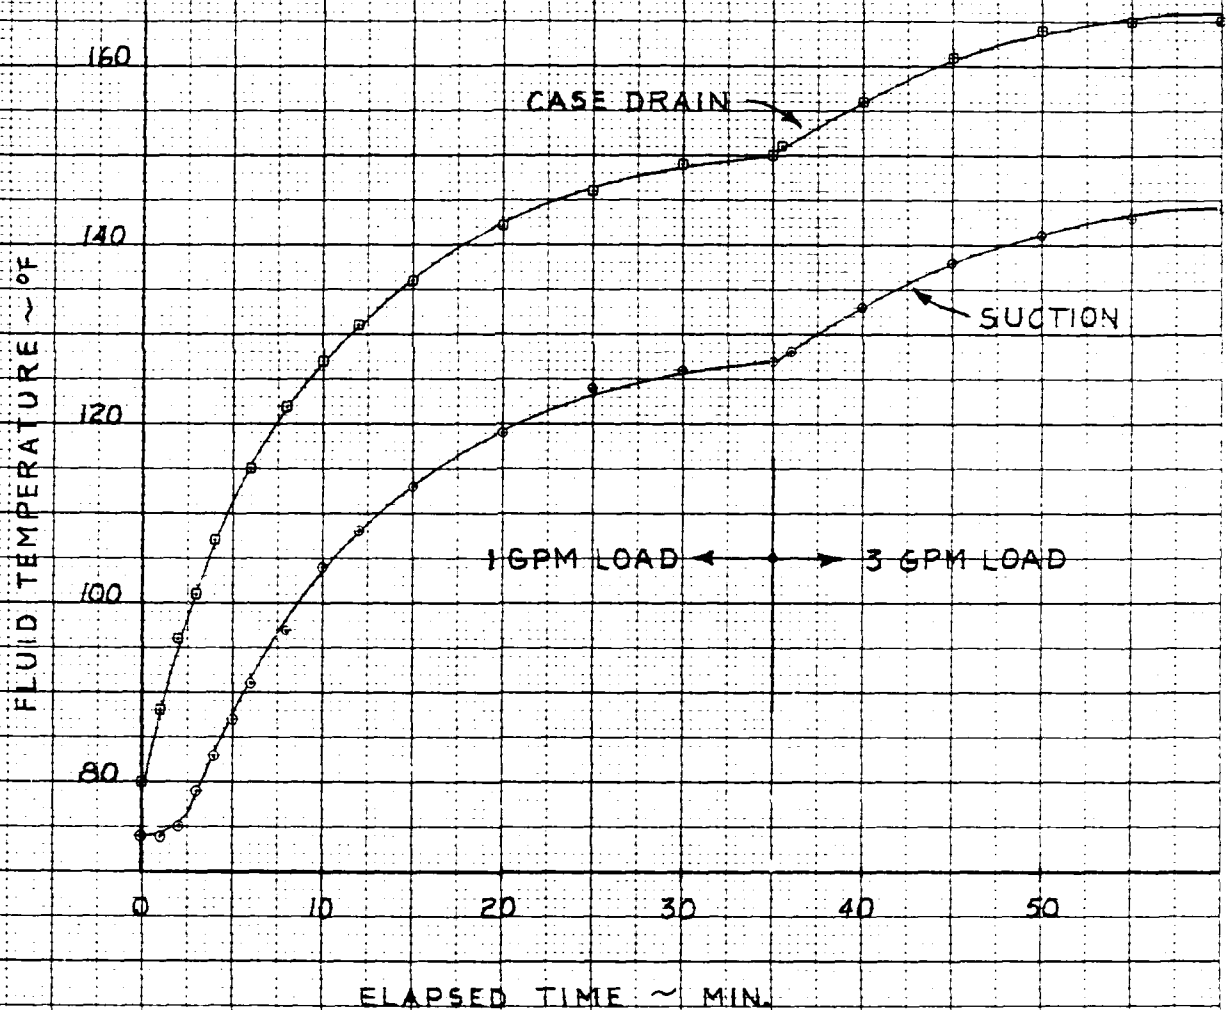
Figure 13. Test stand temperature stabilization

1. AHT-63 PORTABLE TEST STAND MODIFIED FOR 8000 PSI SERVICE
2. TEST STAND OPERATED WITH COVER ON
3. DISCHARGE PRESSURE: 7800 PSI
4. LOAD FLOW (AT RETURN PRESS): NOTED
5. CASE DRAIN FLOW: 7.1 GPM (AVERAGE)
6. TEST STAND RESERVOIR FLUID LEVEL:  $\frac{1}{4}$  FULL
7. AIR TEMPERATURE: +74°F

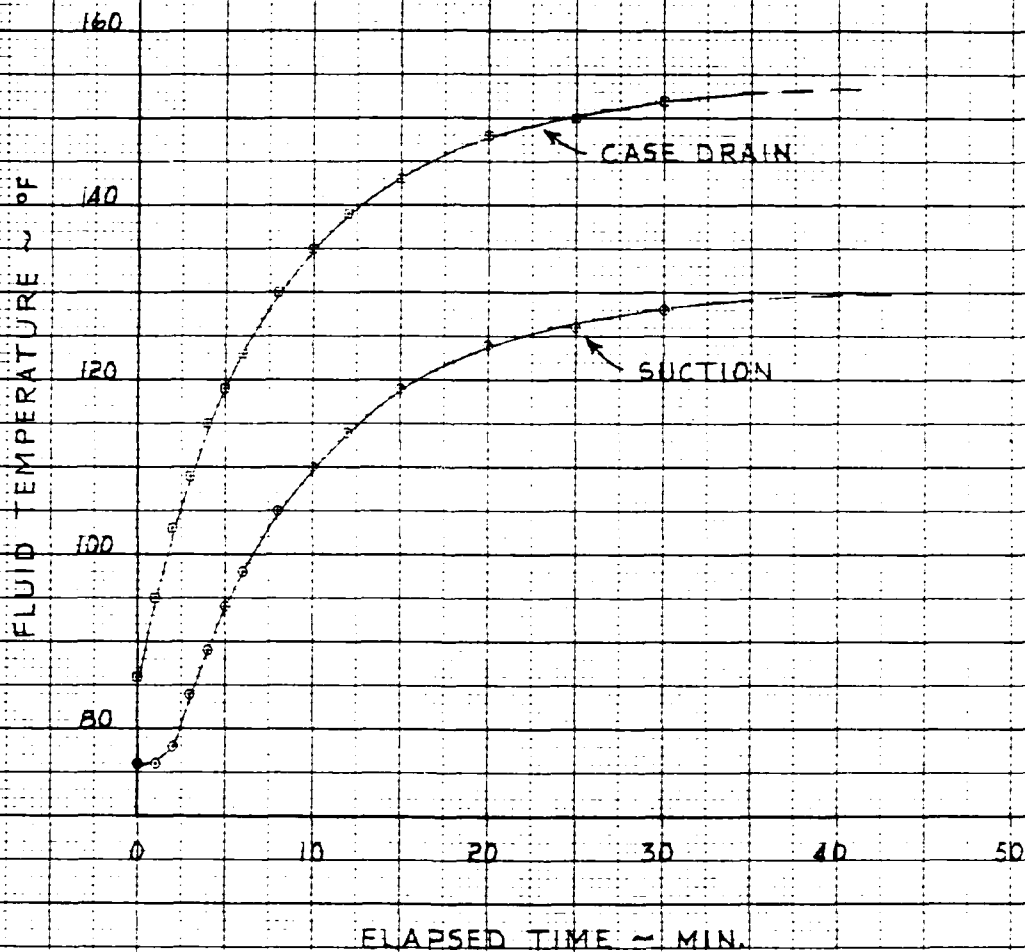
Figure 14. Test stand/LHS simulator temperature stabilization

1. AHT-63 MOD. TEST STAND POWERING FC-1 SYSTEM ON A-7E LHS SIMULATOR (USING A-7E RESERVOIR)
2. ALL FLIGHT CONTROL ACTUATORS OPERATING WITH 2% STROKE AT 3 Hz
3. SYSTEM PRESSURE: 7900 PSI
4. RETURN FLOW: 2.7 GPM
5. CASE FLOW: 5.5 GPM
6. SUCTION PRESSURE: 116 PSI
7. AIR TEMPERATURE: +74 °F

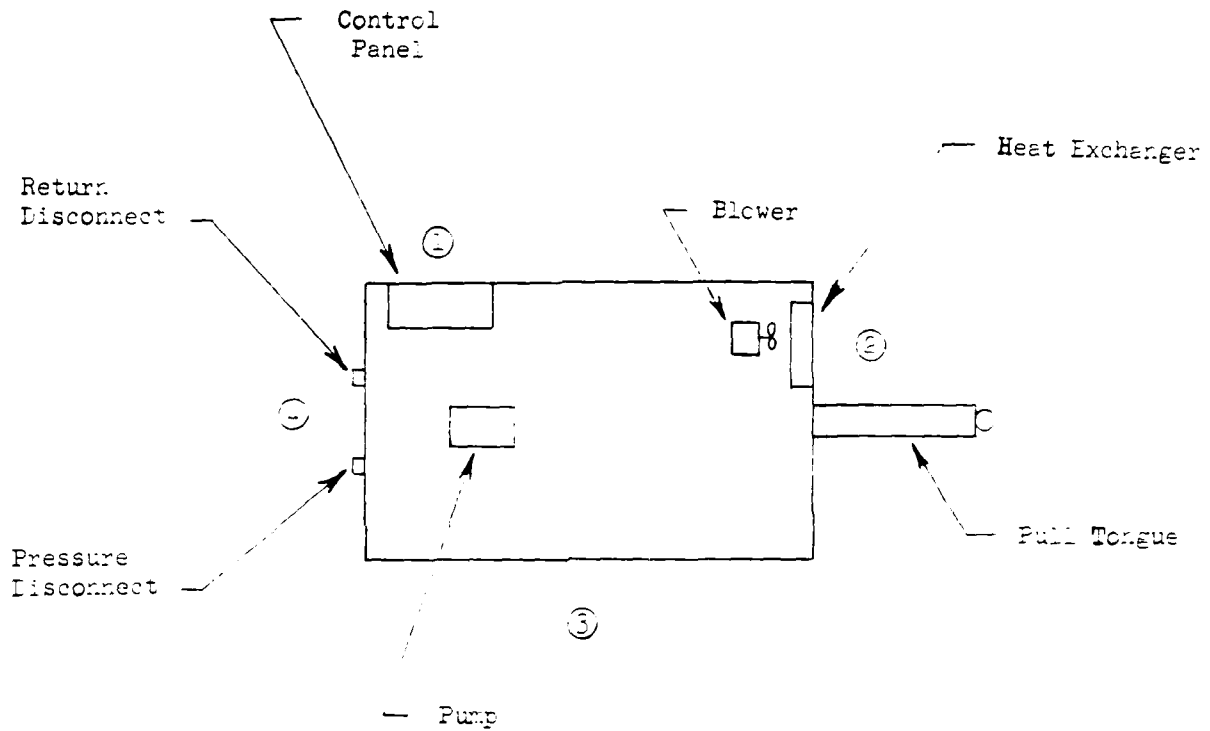
Figure 15. AHT-63 MOD. test stand noise levels

1. Noise measurements taken with Metrosonic Metrologger II approximately 2 ft. from test stand at the indicated locations.
2. Data taken with test stand cover on.

<u>Location</u>	<u>Noise Level, dBa</u>
①	87
②	92
③	83
④	82

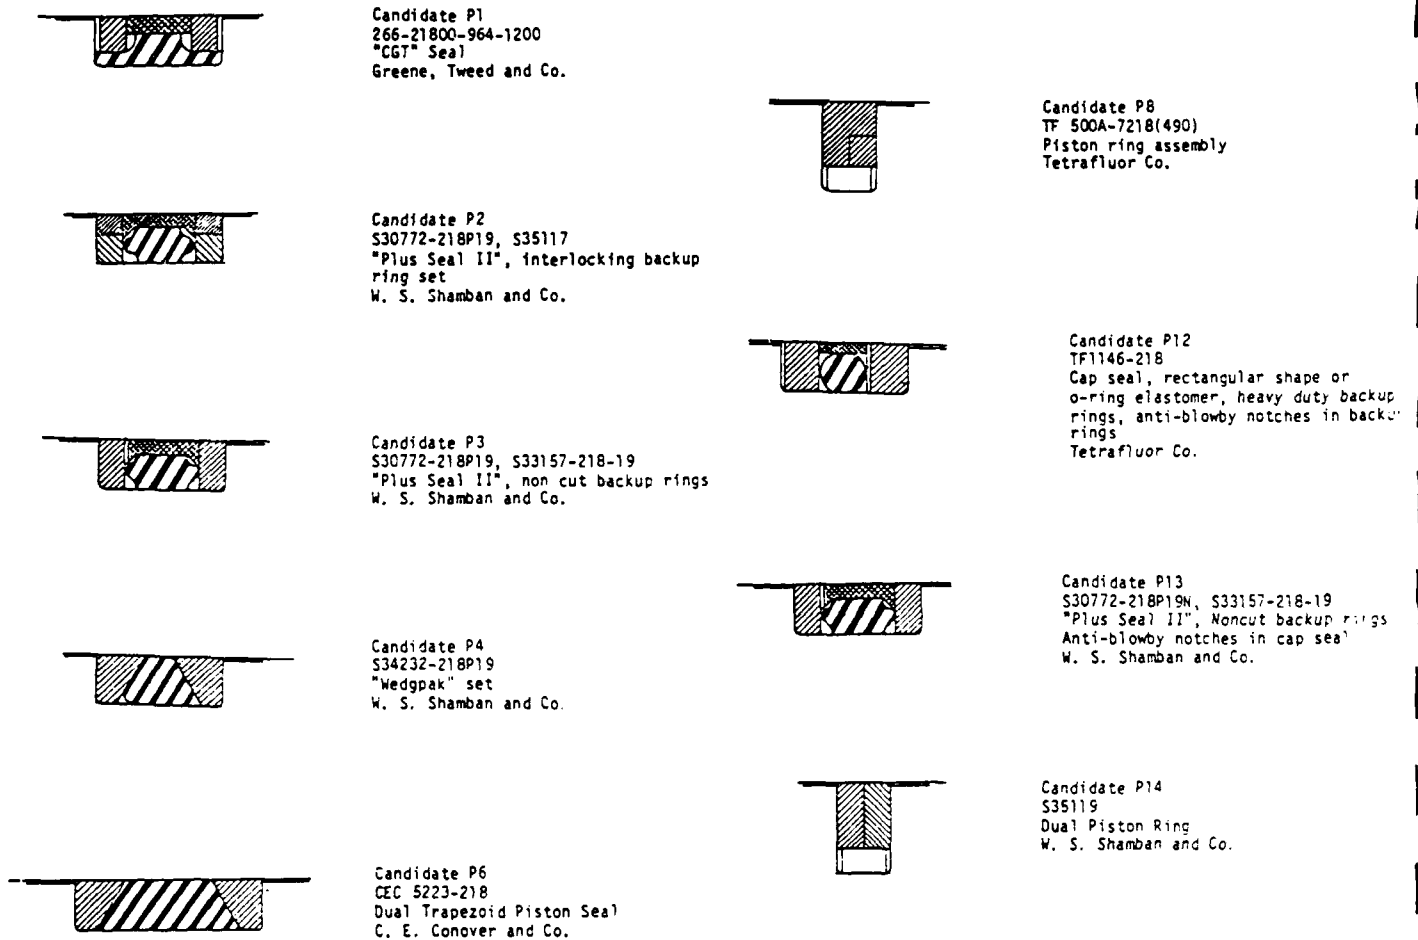
Figure 16. Candidate piston seals

Hydraulic fluid:	MIL-H-83282
System pressure:	8000 psi
Piston seal $\Delta p$ :	6400 psi (80% of 8000 psi)
Fluid temperature:	
Endurance cycling	+250 to +275°F
Leakage checks	-40°F and ambient
Test duration:	400 hr (eight 50 hr blocks)
Endurance cycling:	
+1.75 in. stroke at 9 cpm	90% of each 50 hr block
+0.10 in. stroke at 30 cpm	10% of each 50 hr block

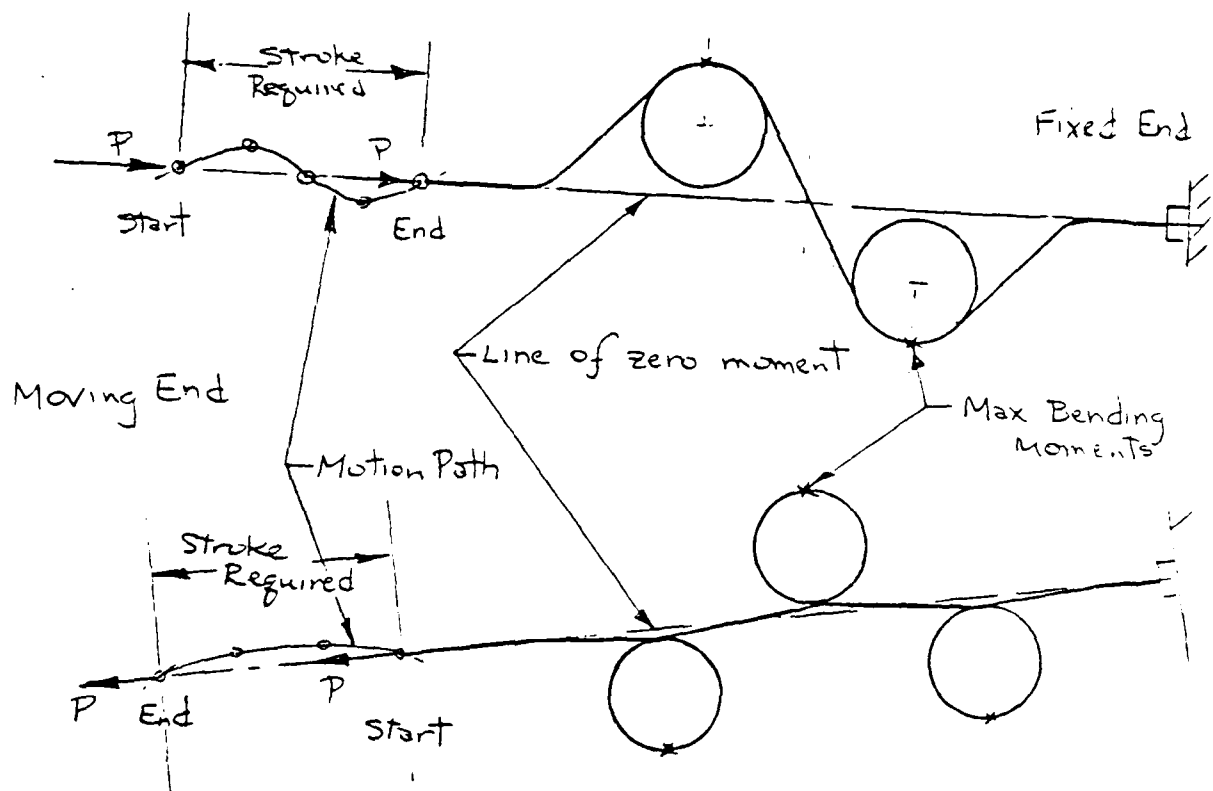
Figure 20. Bending configuration layout

To achieve minimum bending moments at the end fittings, connect the starting and ending points of the moving end with a layout line extended to the fixed end point, Figure 20. Assume no fixity at the ends and calculate the resulting bending moments and stresses. Each element of the coiled tube configuration is then analyzed for deflections. The sum of the deflections relative to the reference axis will give the total motion of the moving end relative to the fixed end. Revisions to the trial configuration will be

necessary to achieve reasonable bending stresses with the required mechanical motion. Design to wind up coils (not unwind). To decrease the spring rate and bending stresses, increase the number of tube coils and/or coil diameter. Theoretical bending stresses are compared to allowable bending stresses to determine a satisfactory fatigue life. Additional revisions in the configuration may be required to produce a satisfactory fatigue life when internal pressure stresses, ovality stresses, and vibration stresses are considered.

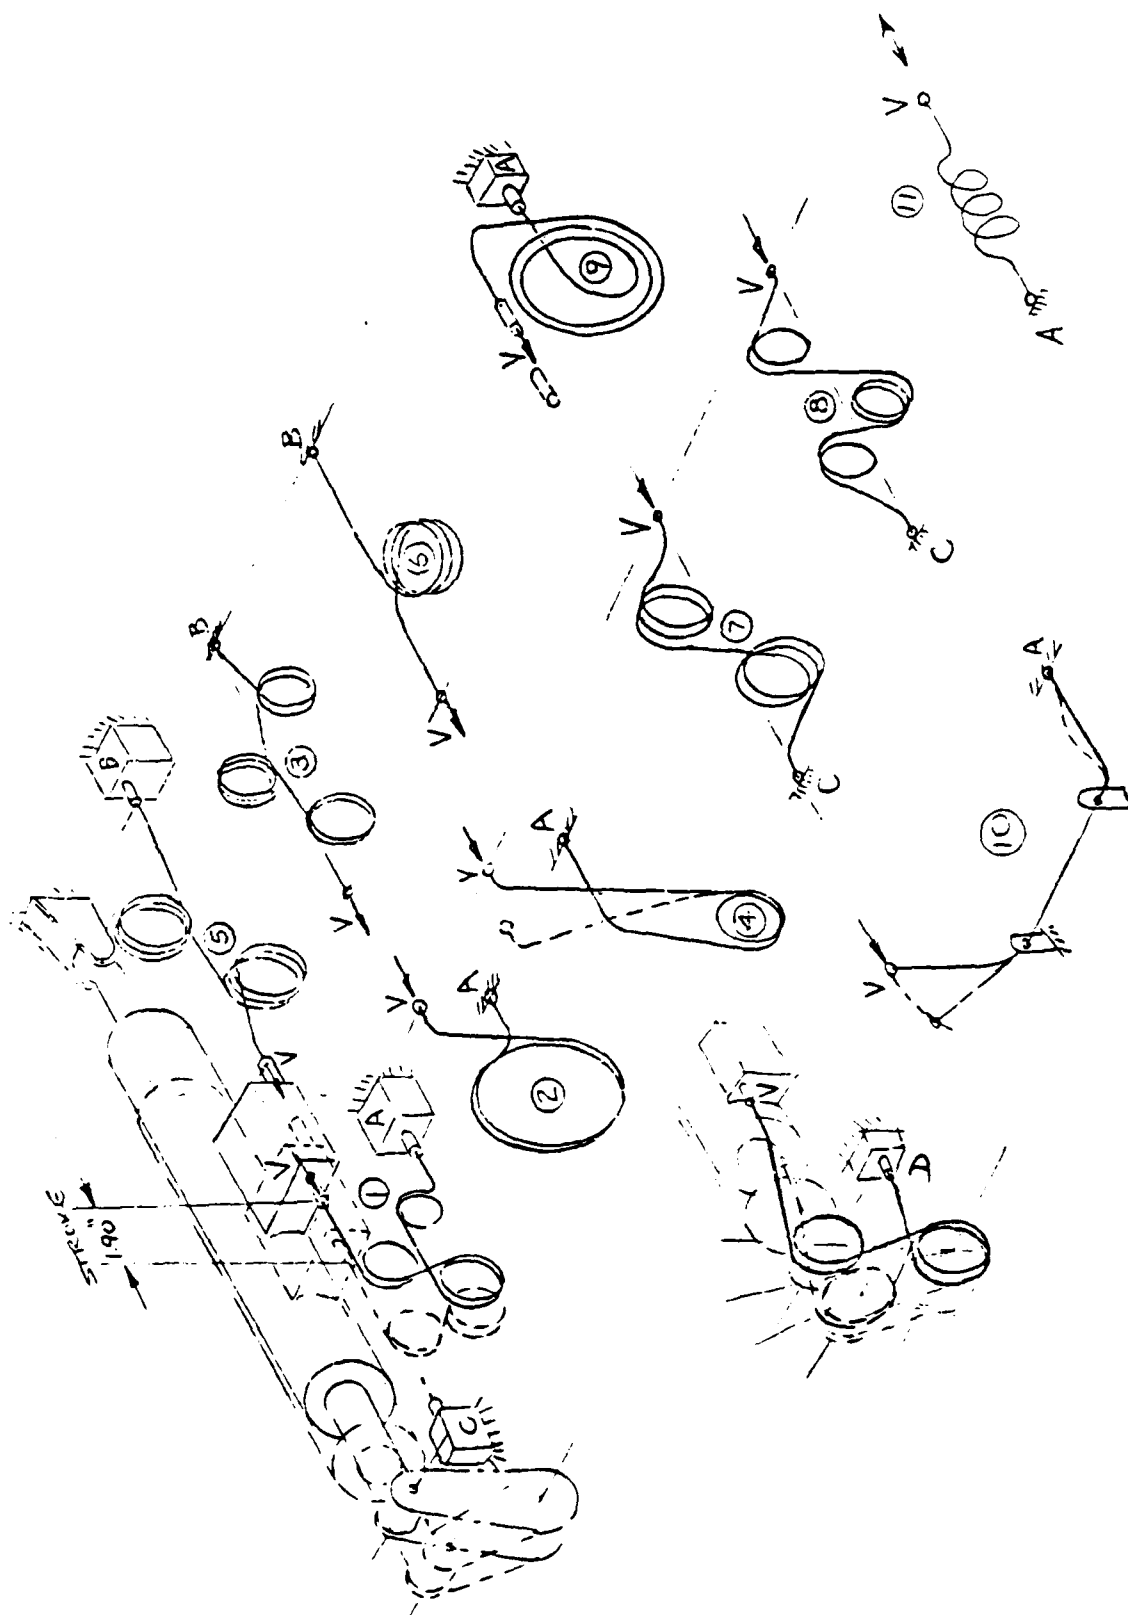
Figure 21. Coil tube configuration examples

Eleven different coil tube configurations are depicted on Figure 21. Although other configurations are possible, the examples given cover most of the practical variations. Appendix D contains stress analyses of configurations 1, 2, and 3; a computer example is run for configuration 4.

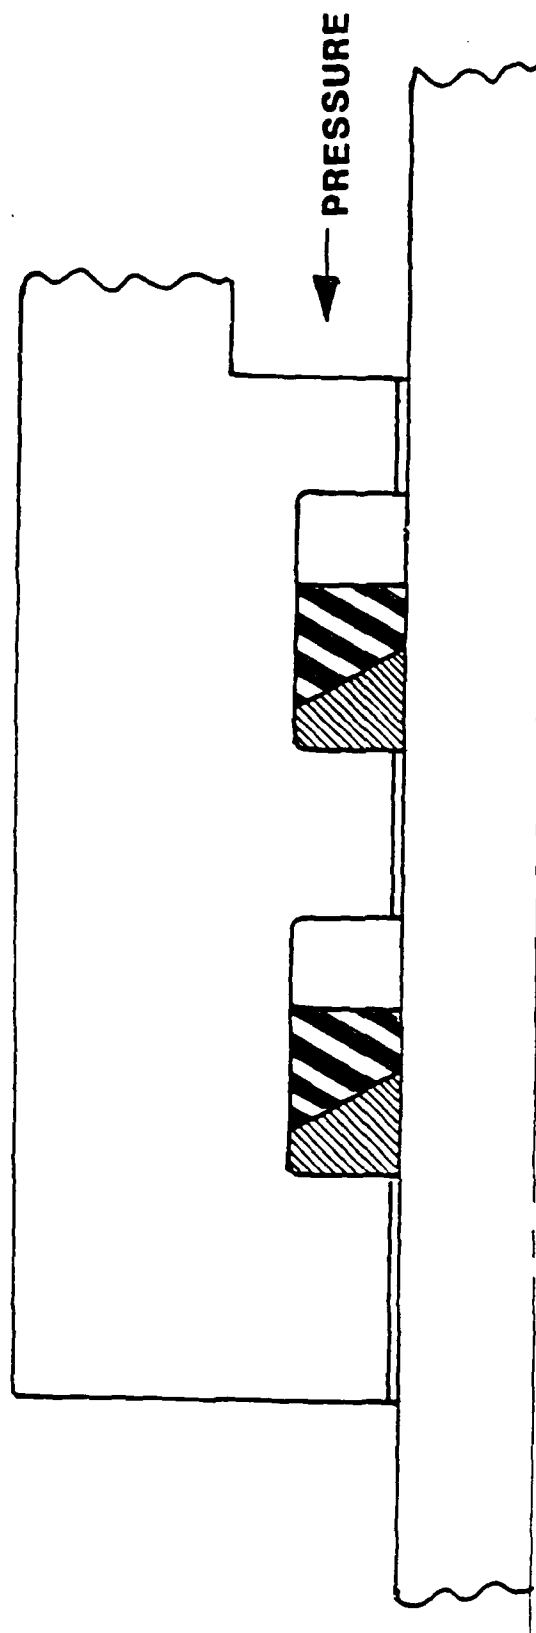
Figure 6. Alternate Rod Seal System Tested

**TRAPEZOID ROD SEAL (2 PLACES)  
GREENE, TWEED ELASTOMER CODE 964  
P5 BACKUP MATERIAL  
UNVENTED**

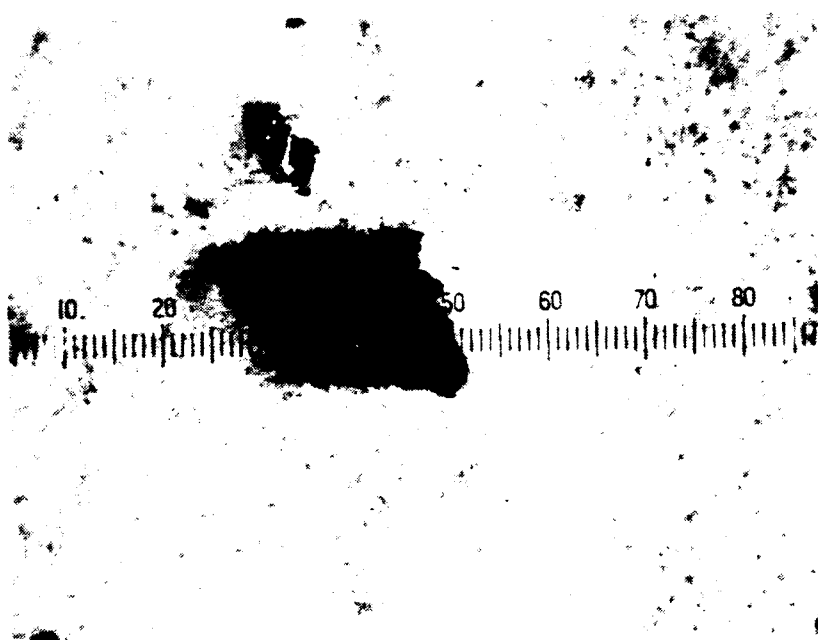
Oblique Lighting  
(200X - Magnification  
Reticle: 6.8 microns/div)

The Type I(a) particle depicted above looked black regardless of the angle of lighting. This particle is photomicrographed at 200X to show the surface roughness that may explain its dark appearance under all angles of incident of light.

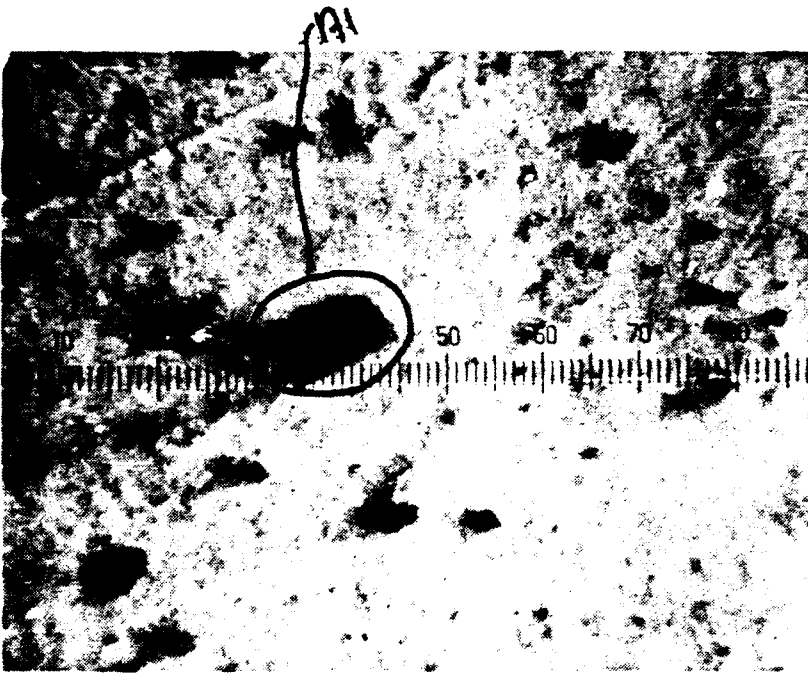
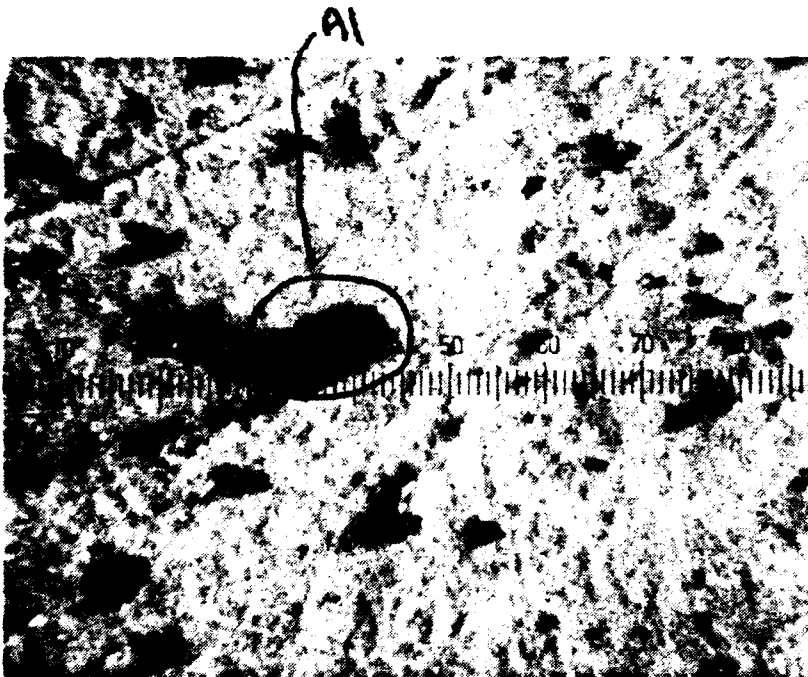
Black Particle Type - I (b)

The "black residue" particle labeled 1(b) contained major aluminum, minor sulfur with a trace of chromium and zinc. These particles were filtered mainly by APM (3 micron absolute) filters in the LHS filter pressure-line location. These particles appeared black under all angles of of the light source used to photomicrograph these particles.

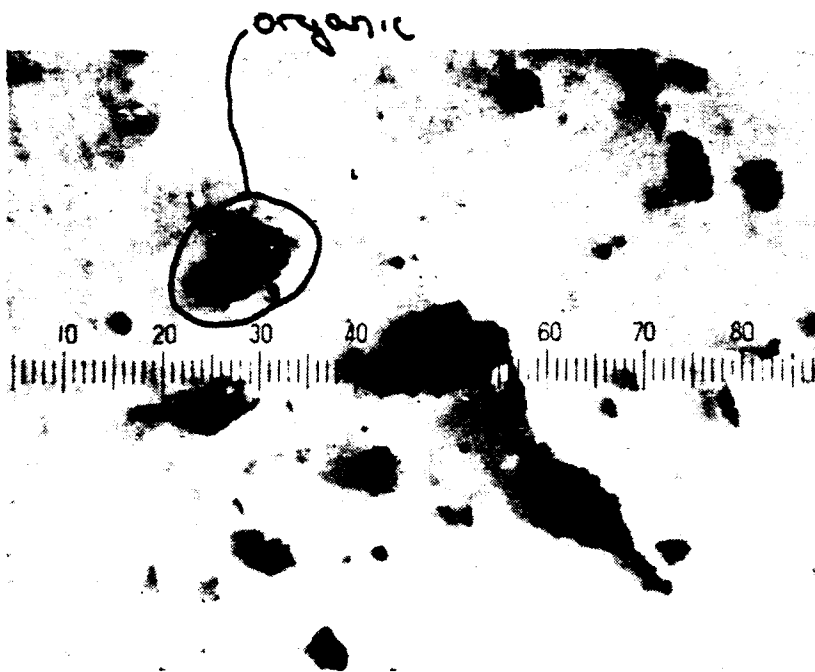
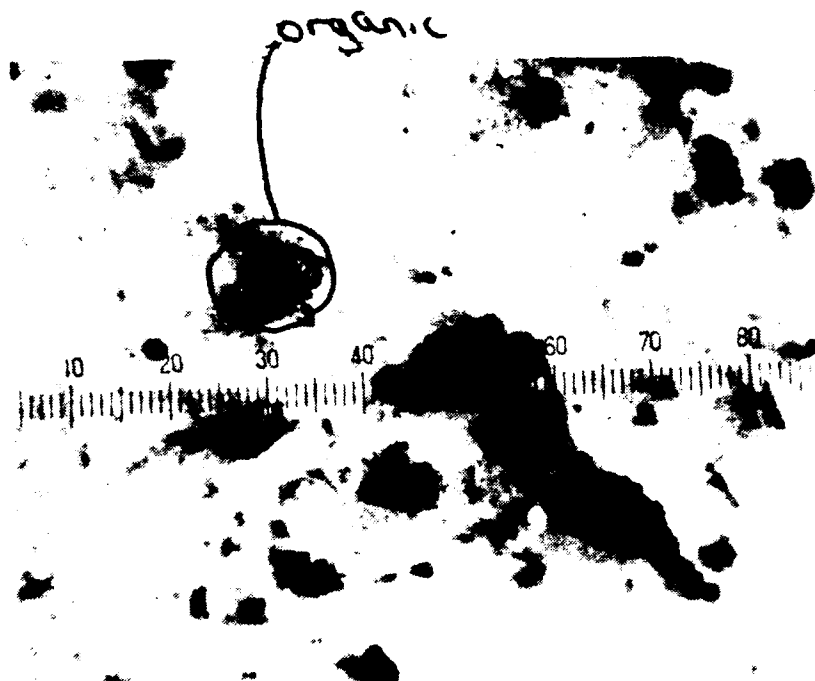
Black Particle Type - I (c)

The "black residue" particle labeled 1(c) contained only a trace of aluminum. It is believed this particle may be composed largely of organic materials (i.e. carbon; oxygen; nitrogen). These particles were filtered mainly by APM (5 micron absolute) filters in the pressure-line of the IHS. These particles appeared black under all angles of the light source.
